How to Resolve “Code 19” Error – SG Ultra Max USB IrDA Adapter

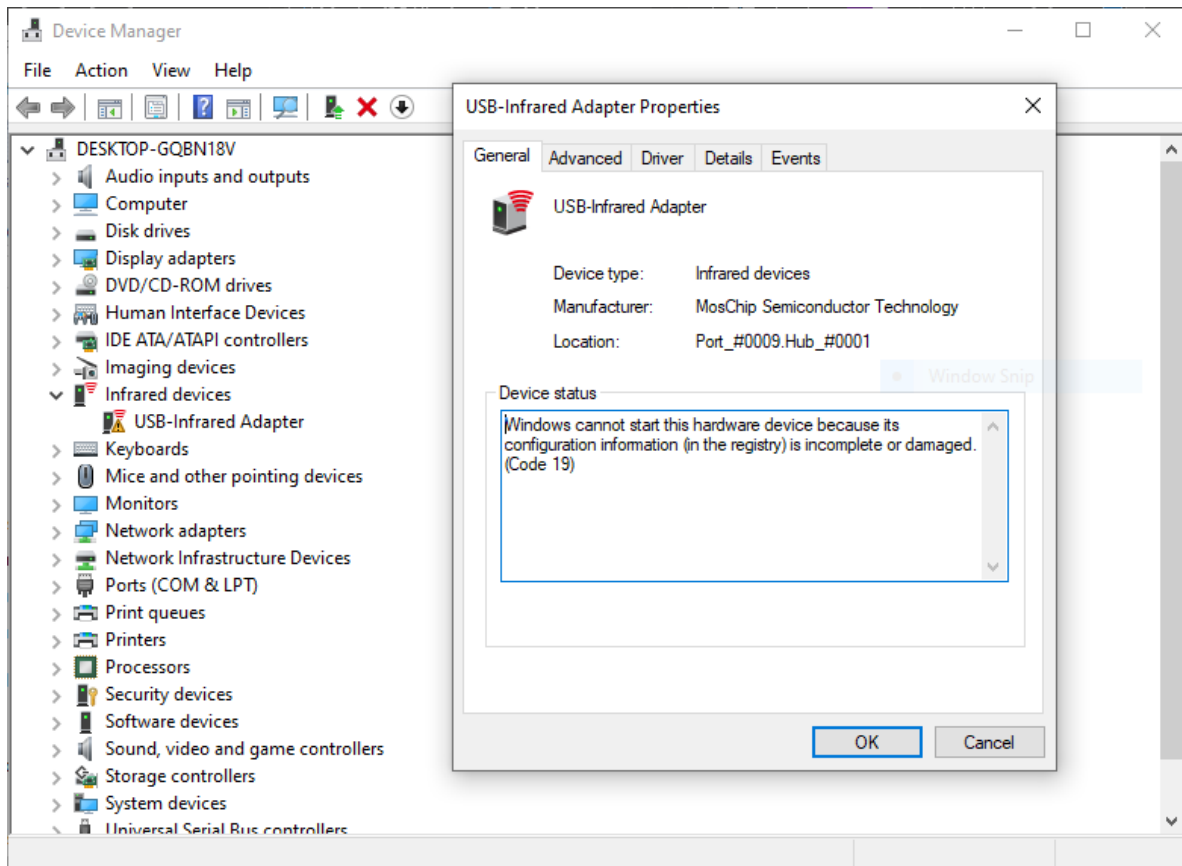
If your PC is running Windows 10 and is updated to system version 1903, you will likely encounter the following Code 19 error in the device status window when attempting to plug in the USB IR Adapter:

In order to resolve the issue and get the IrDA adapter to work, follow these steps:

1. Go to **Start > Settings > Apps**.
2. In the left panel, make sure you're on **Apps & features**.
3. In the right section, under Apps & features click on **Optional features**.
4. Then, in the new windows, click on **Add a feature**.
5. From the list that appears, select **IrDA infrared** to install (Note: if you don't see any features listed in the Add a feature window, you will need to switch to a user with Admin privileges to see them).
6. Make sure you have the latest driver version, and finally **restart your PC**. The driver should now be cleared of the Code 19 error and the adapter will once again be functional.
