EAGLE EYE WHITE PAPER

Title	Lead-Calcium Battery Natural Aging
Document No.	WP-050720-1

Lead-Calcium Battery Natural Aging

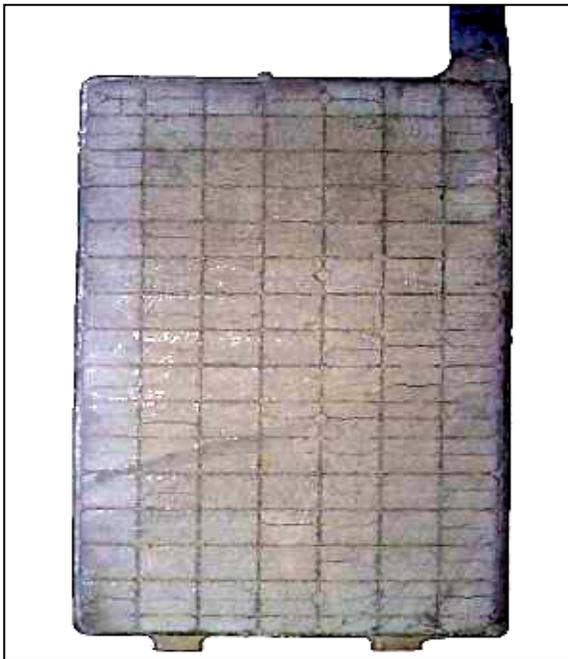
New Plate

The following pictures demonstrate the effect. Note that new and aged plates shown are of different plate designs. These are called pasted flat positive plates because the active material, lead oxide PbO_2 , is pasted on to a cast grid of a lead alloy, in this case, lead-calcium $PbCa$.

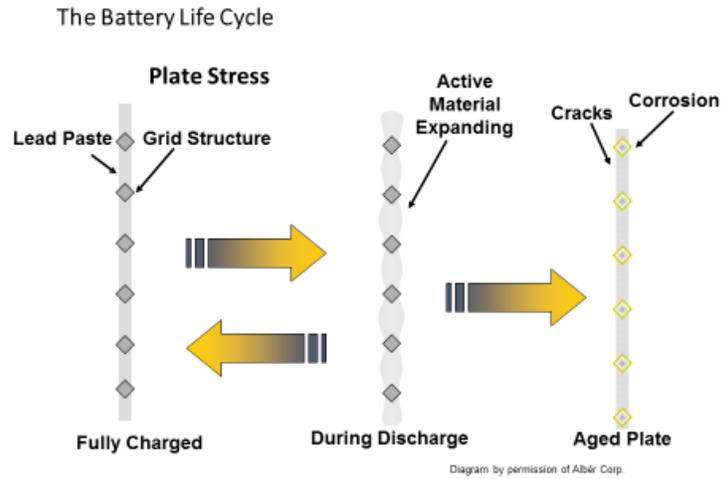
The following figure demonstrates how cycling effects the positive plate structure. As the battery is discharged and recharged, the positive plates expand and contract causing it to crack and corrode.

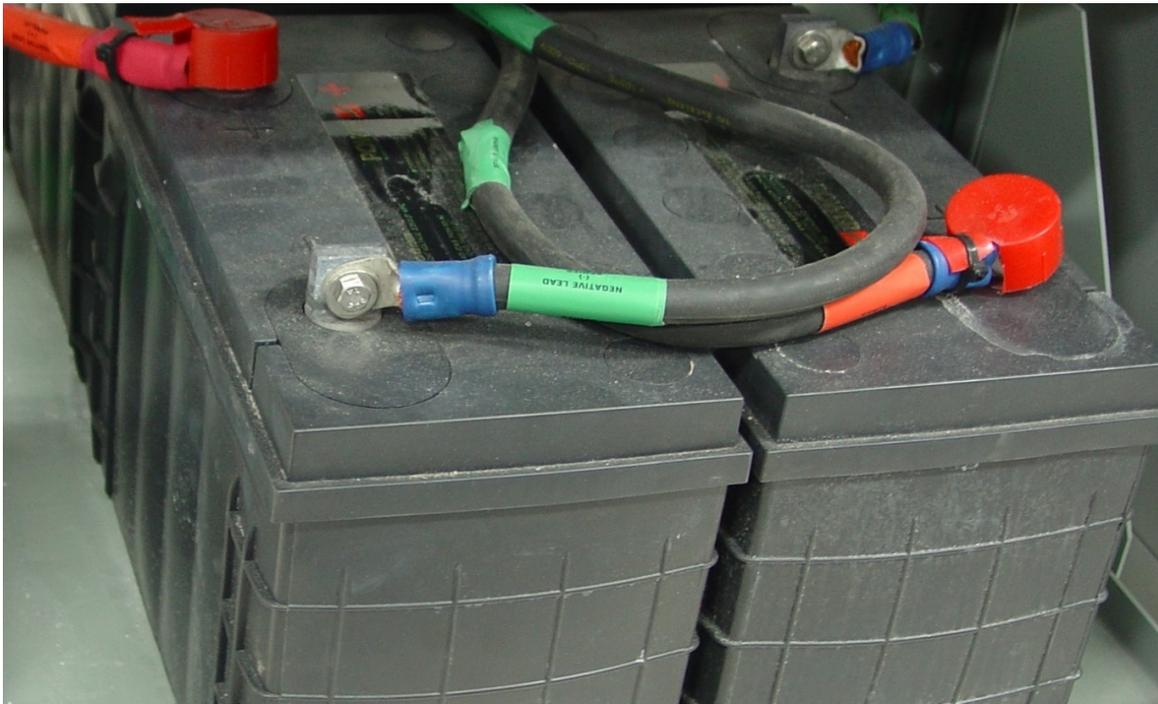
VRLA AGM Battery Unit

The following pictures demonstrate cover crack most likely caused by positive plate growth. Note that the cracks and post growth emanate from the positive posts.

Please note that all battery cover cracks are not confined to any manufacturer or are caused by positive plate growth. The same applies to post seal leaks. There have been cases of cover cracks and post seal growth and leaks being caused by defective cover materials and rough handling, bad installation, stress on posts by incorrect installation of inter-cell connectors and cables. etc.
