EAGLE EYE WHITE PAPER

Title	Lead-Calcium Battery Natural Aging
Document No.	WP-050720-1

Lead-Calcium Battery Natural Aging

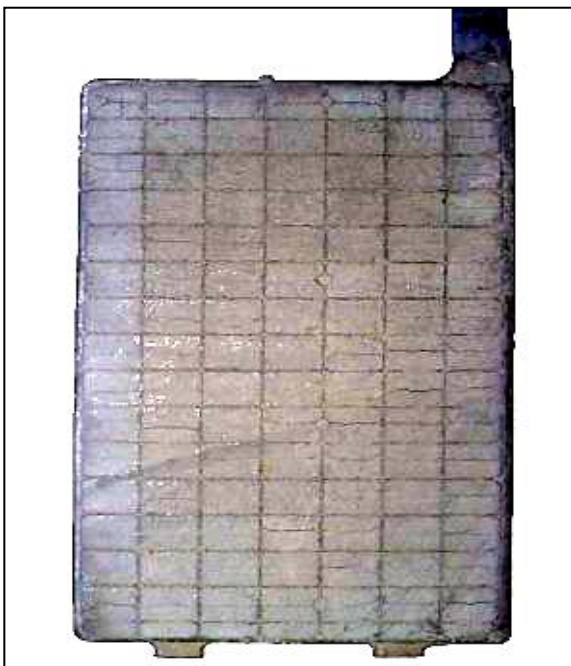
New Plate

The following pictures demonstrate the effect. Note that new and aged plates shown are of different plate designs. These are called pasted flat positive plates because the active material, lead oxide PbO_2 , is pasted on to a cast grid of a lead alloy, in this case, lead-calcium $PbCa$.

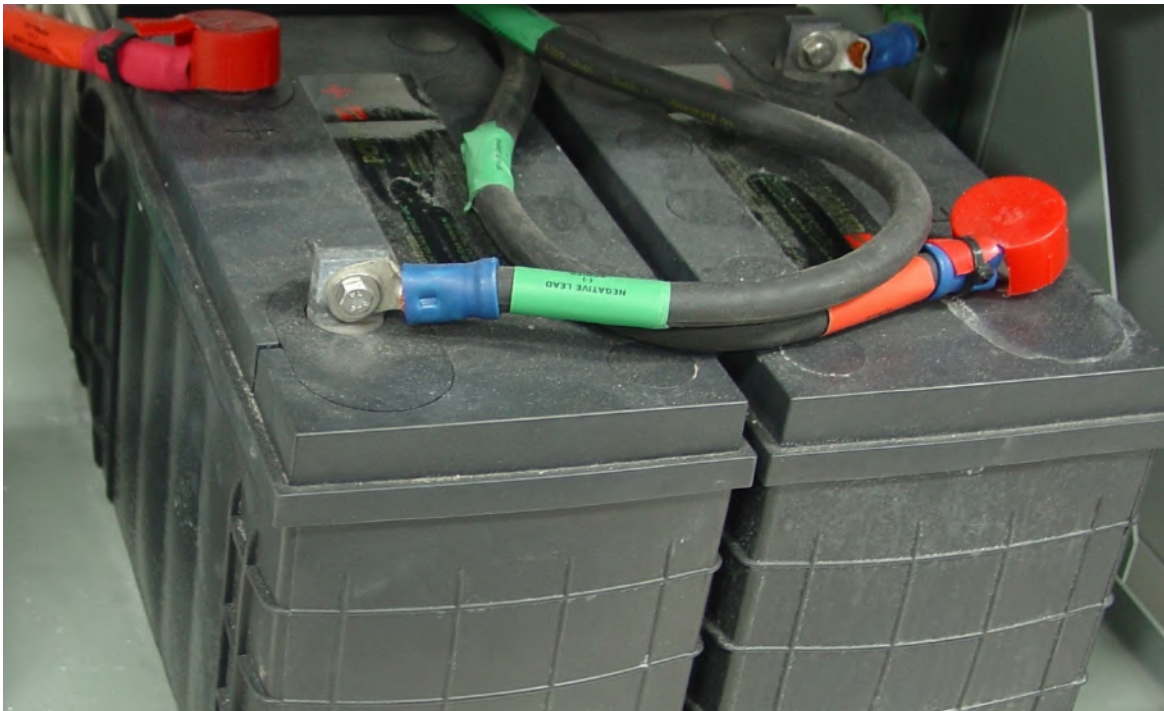
VRLA AGM Battery Unit

The following pictures demonstrate cover crack most likely caused by positive plate growth. Note that the cracks and post growth emanate from the positive posts.

Please note that all battery cover cracks are not confined to any manufacturer or are caused by positive plate growth. The same applies to post seal leaks. There have been cases of cover cracks and post seal growth and leaks being caused by defective cover materials and rough handling, bad installation, stress on posts by incorrect installation of inter-cell connectors and cables. etc.
